Stähli, Barbara E; Gebhard, Catherine; Falk, Volkmar; Corti, Roberto; Jenni, Rolf; Tanner, Felix C (2013). Regurgitation after Edwards SAPIEN valve implantation: truly paravalvular or 'supra-skirtal'? European Heart Journal, 34(16):1214.

CARDIOVASCULAR FLASHLIGHT

Regurgitation after Edwards SAPIEN valve implantation: truly paravalvular or 'supra-skirtal'?

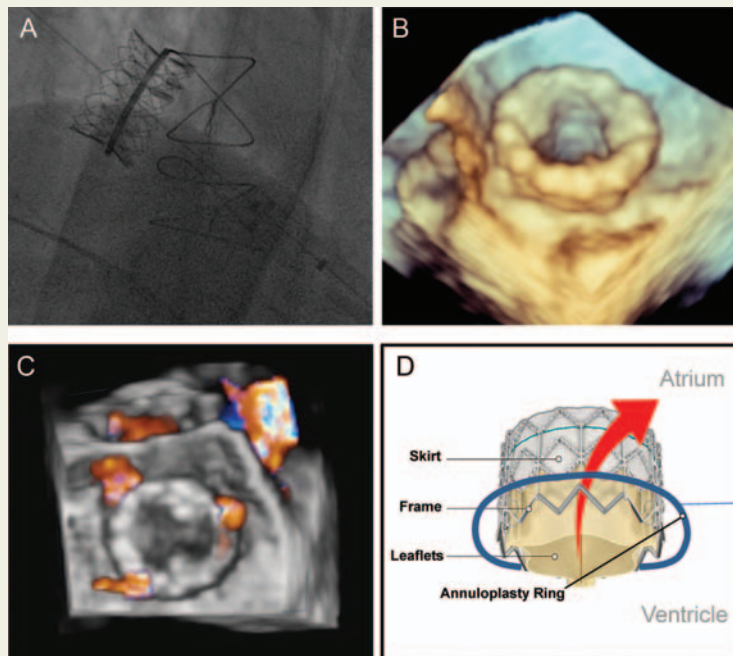
A 73-year-old male was referred with severe mitral regurgitation 9 years after mitral valve annuloplasty with a 32-mm Edwards Lifesciences ring. On the basis of an anticipated high perioperative risk related to chronic kidney disease and left ventricular systolic dysfunction, mitral valve-in-ring implantation using a 29-mm Edwards SAPIEN prosthesis was performed by transapical access (Panel A). Postprocedural three-dimensional transoesophageal echocardiography revealed three paravalvular regurgitation jets at the 3, 7, and the 11 o'clock positions (Panels B and C).

In this patient, we observed a third type of regurgitation in Edwards SAPIEN prostheses, which is caused by the device design. Edwards SAPIEN prostheses are built up by bovine pericardial tissue leaflets fixed on a stainless steel frame. A polyethylene terephthalate skirt partially covers the steel frame. However, since the skirt covers the basal two-thirds of the frame only, regurgitation through its uncovered part may occur (arrow, Panel D; adapted from www.edwards.com/products/transcathetervalve/Pages/sapienthv.aspx).

This type of regurgitation was seen in the patient presented here, since the skirt is positioned in the left atrium rather than the annuloplasty ring. The commissures cover the whole length of the steel frame, and the regurgitation jets are therefore located in between the commissures and positioned $\sim 120^\circ$ apart from each other. In patients with Edwards SAPIEN prostheses in aortic position, the same phenomenon may be observed with prostheses implanted too apically. However, as the left ventricular outflow tract is narrow, regurgitation jets are more difficult to visualize.
